PUBLISHED: 20-MAY-2019
2018.0 RANGE ROVER (LG), 501-25B

BODY REPAIRS - WATER LEAKS

WATER LEAKS (G1454472)

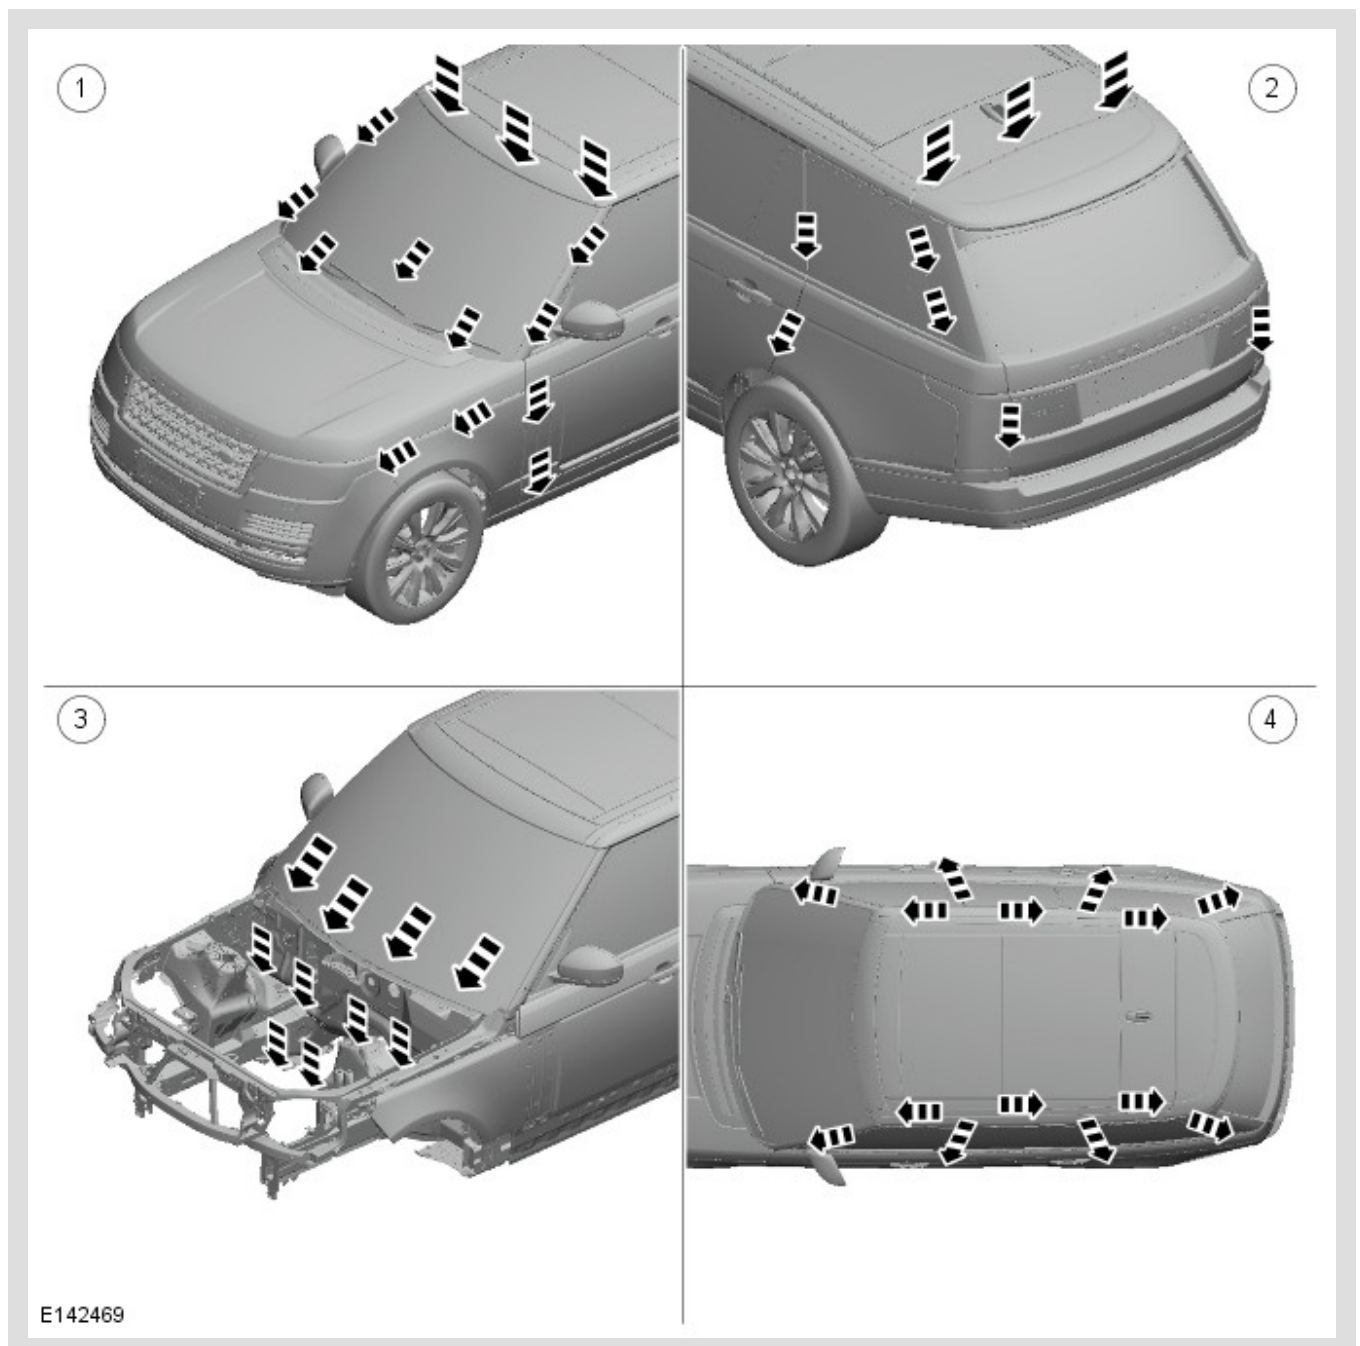
Water drainage system (illustration for reference only)

ITEM	DESCRIPTION
1	Water drainage, front
2	Water drainage, side and rear
3	Engine compartment drainage
4	Roof drainage

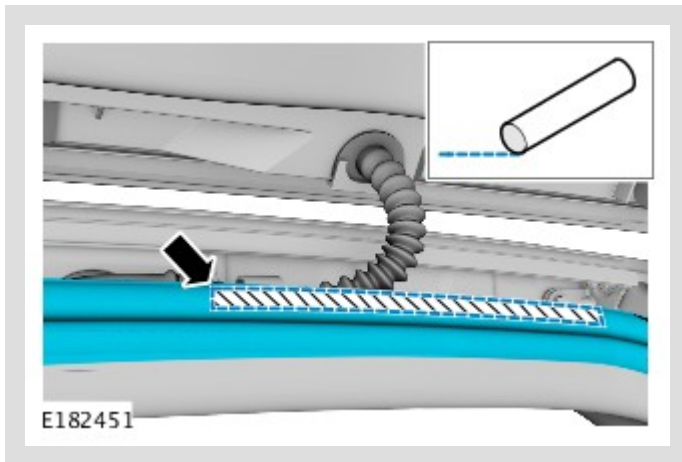
Apply a white chalk mark in the area shown to the tailgate aperture seal.

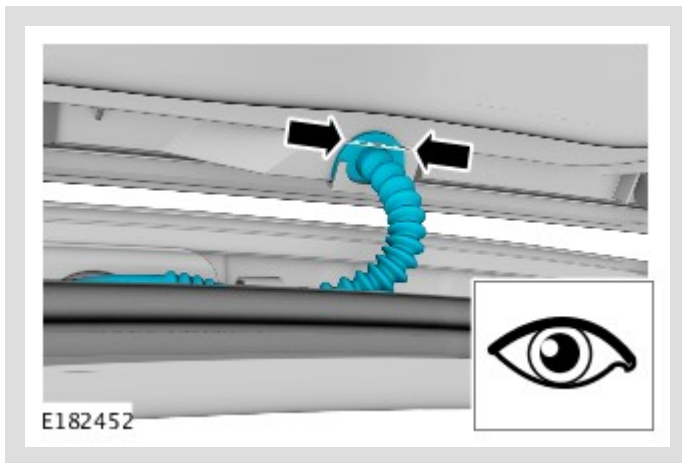
Check for any chalk transfer to the tailgate grommet seals in the area shown.

- Confirm the chalk contact area that needs removing from the tailgate grommet.
