PUBLISHED: 20-MAY-2019
2018.0 RANGE ROVER (LG), 501-25B

BODY REPAIRS - WATER LEAKS

WATER LEAKS (G1454472)

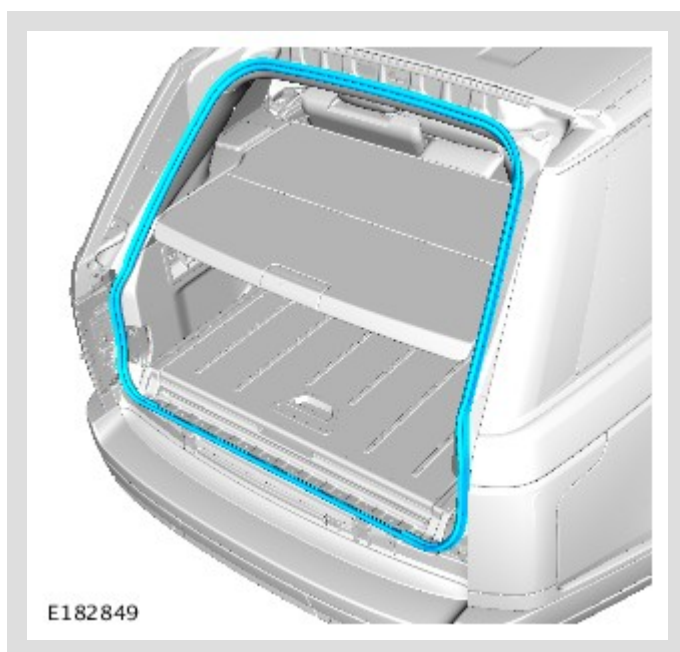
Tailgate

- Diagnosis:
 - Ingress of water through the tailgate aperture seal.
- If this process is carried out please use **SRO 76.19.89.32**
- Corrective action:
 - Remove and discard the damaged tailgate aperture seal.
 - Install a new tailgate aperture seal.

Repeat this step for both tailgate grommet seals.
