Connector Face

ENGINE COMPARTMENT LH HARNESS

Module-Speed control

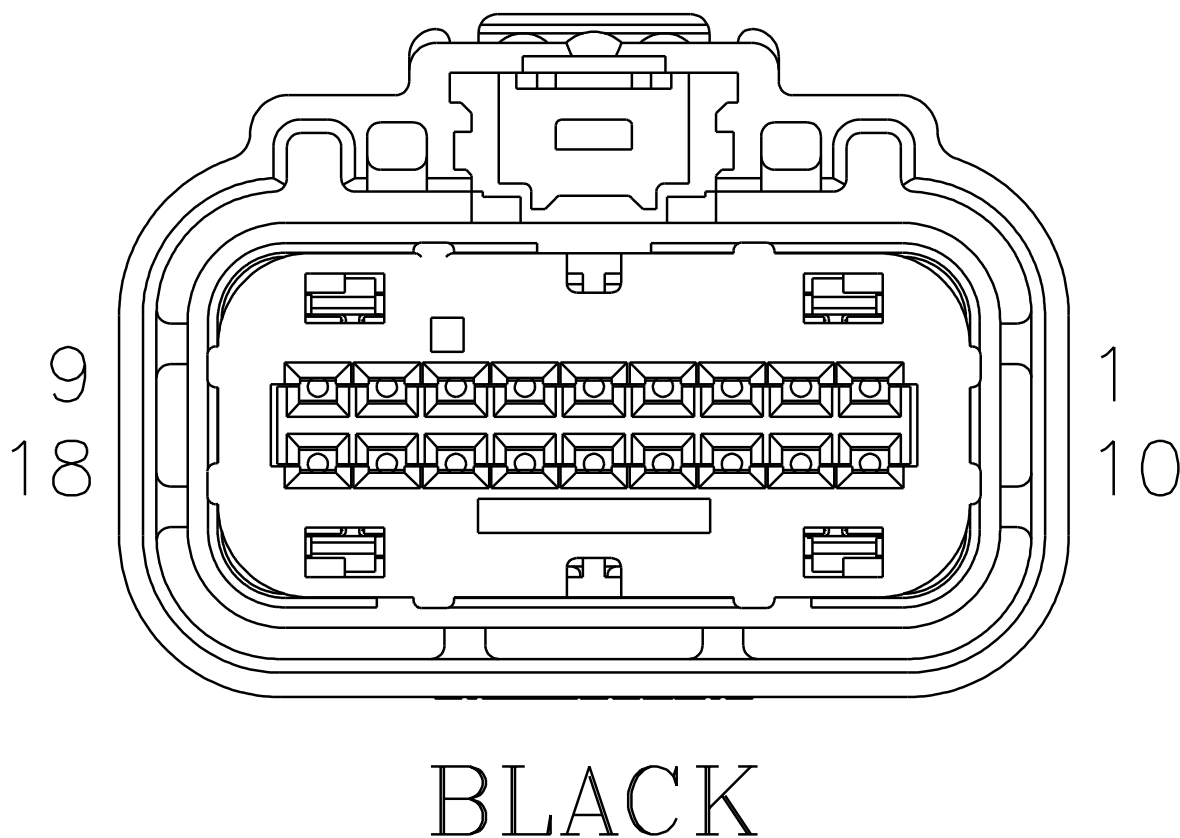
Housing

Engineering Part Number

4R3T-14A464-AB-014

Colour

BLACK

Cavities

18

Description

Location

Behind center of bumper

CAV	CSA	COL	CCT	DESTN
1	0.5	BU-GN	GTDAD	C31-L1
3	0.5	BK	GTDAD	G1D129BL
7	0.5	GY-BU	GTDAD	S1DB26A
8	0.5	GN-OG	GTDAD	S1DB25A
10	0.35	WH-VT	GTDAD	C2BP01H
